**Flood Control Project Maintenance
Levee Inspections****2009 Channel Summary Report****Overall Unit and Item Ratings****Fairfield Suisun Sewer District**

Flood Control Project Maintenance**Unit Cover Sheet****2009 Channel Inspection Results****Fairfield Suisun Sewer District**

Channel
Laurel Creek

Fairfield Suisun Sewer District

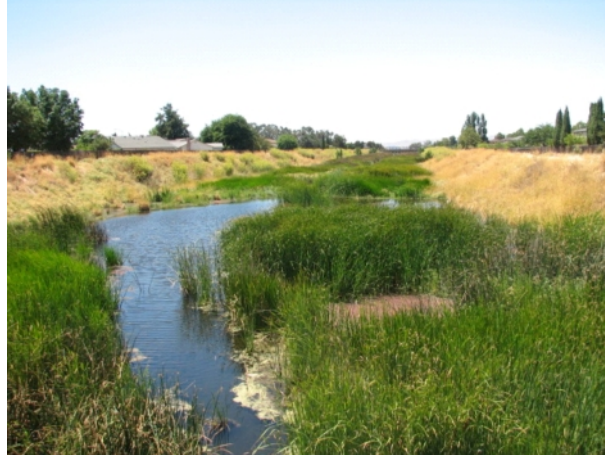
Levee Mile Report Line	26
Start Levee Mile	0.00
End Levee Mile	0.00
Location	
Category	Channels
Item	Vegetation & Obstructions
Downstream view from Pintail Ave. 38.24854 - 122.00637	
john_gw_20090723_33.jpg

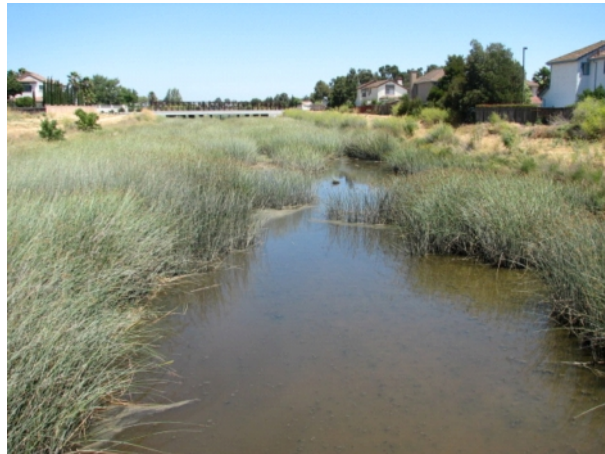
Levee Mile Report Line	31
Start Levee Mile	0.00
End Levee Mile	0.00
Location	
Category	Channels
Item	Vegetation & Obstructions
Upstream view from Anderson Dr. looking towards Hwy. 12 38.24129 -122.01205	
john_gw_20090723_34.jpg

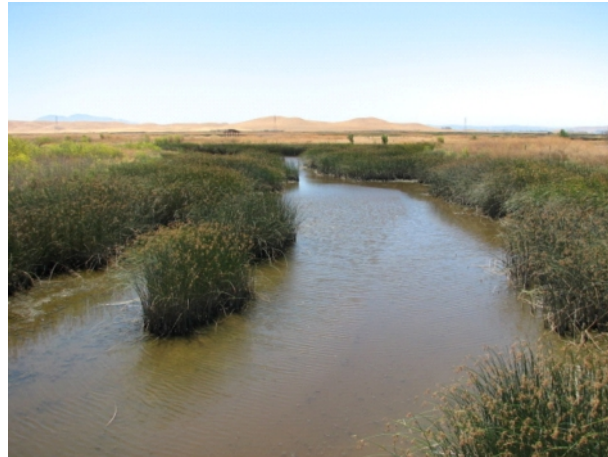
Levee Mile Report Line	36
Start Levee Mile	0.00
End Levee Mile	0.00
Location	
Category	Channels
Item	Vegetation & Obstructions
Downstream view from Anderson Dr. looking to Suisun Bay 38.24129 -122.01205	
john_gw_20090723_36.jpg

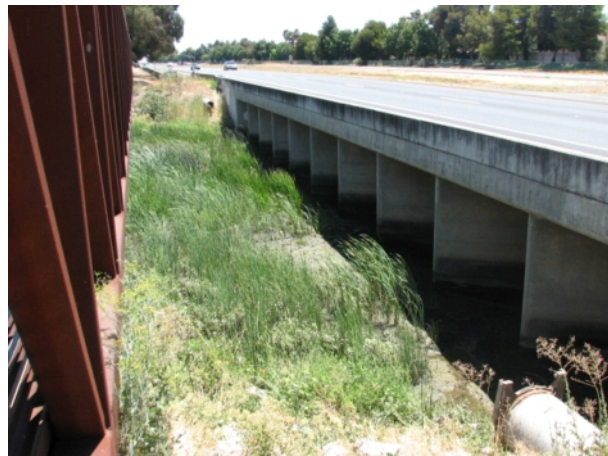
Levee Mile Report Line	36
Start Levee Mile	0.00
End Levee Mile	0.00
Location	
Category	Channels
Item	Vegetation & Obstructions
Downstream view picture from upstream side of Hwy. 12 between bike path and Hwy. 38.24361 - 122.01057	
john_gw_20090723_37.jpg

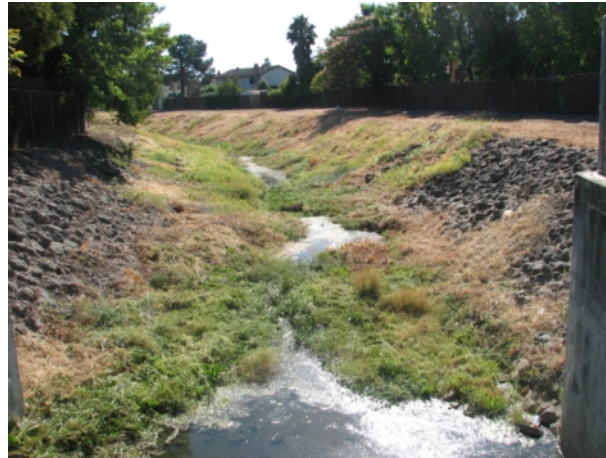
Levee Mile Report Line	6
Start Levee Mile	0.00
End Levee Mile	0.00
Location	
Category	Channels
Item	Vegetation & Obstructions
Downstream view from N. Texas Street, 38.28058 -122.03391	
johngw_20090723_1.jpg

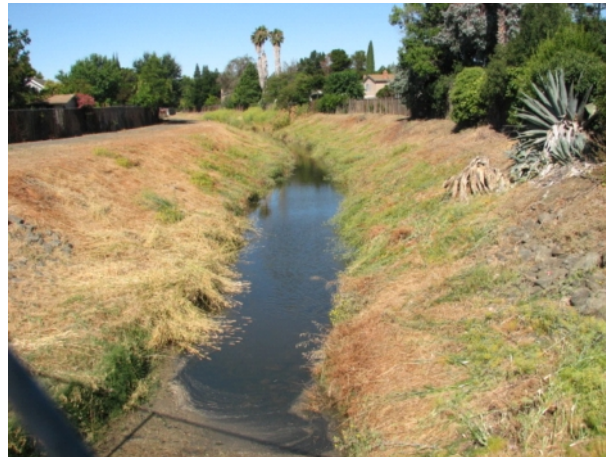
Levee Mile Report Line	11
Start Levee Mile	0.00
End Levee Mile	0.00
Location	
Category	Channels
Item	Vegetation & Obstructions
upstream view from Camrose Ave.38.28166 - 122.03049	
johngw_20090723_2.jpg

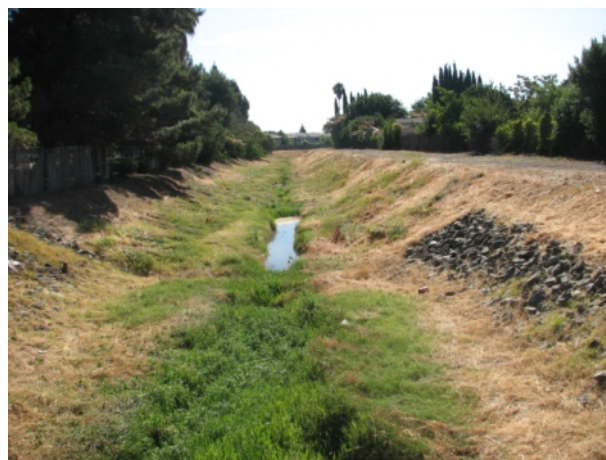
Levee Mile Report Line	16
Start Levee Mile	0.00
End Levee Mile	0.00
Location	
Category	Channels
Item	Vegetation & Obstructions
Downstream view from Camrose Ave. 38.28166 - 122.03049	
johngw_20090723_3.jpg

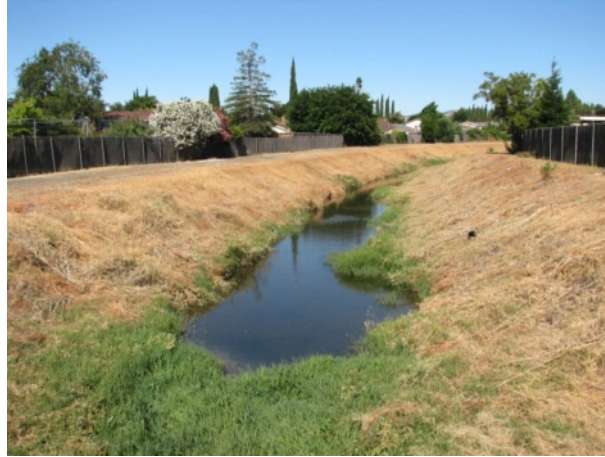
Levee Mile Report Line	21
Start Levee Mile	0.00
End Levee Mile	0.00
Location	
Category	Channels
Item	Vegetation & Obstructions
Upstream view from Dover Ave. 38.28099 - 122.02475	
johngw_20090723_4.jpg

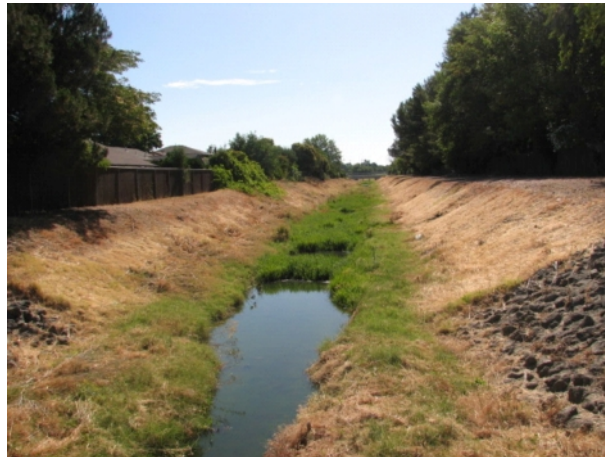
Levee Mile Report Line	26
Start Levee Mile	0.00
End Levee Mile	0.00
Location	
Category	Channels
Item	Vegetation & Obstructions
Downstream view from Dover Ave. 38.28099 - 122.02475	
johngw_20090723_5.jpg

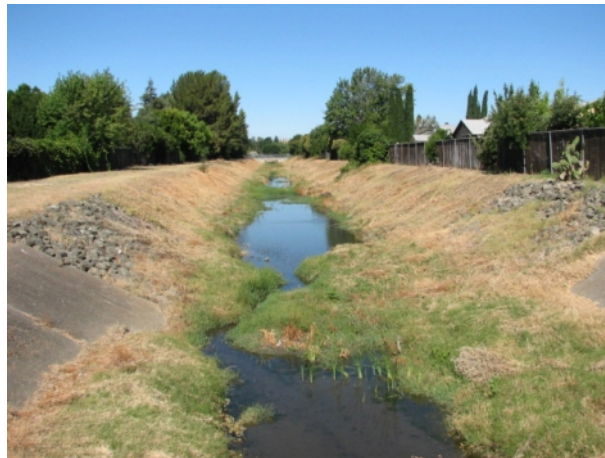
Levee Mile Report Line	31
Start Levee Mile	0.00
End Levee Mile	0.00
Location	
Category	Channels
Item	Vegetation & Obstructions
Upstream view from Gulf Dr. 38.28100 - 122.02057	
johngw_20090723_6.jpg

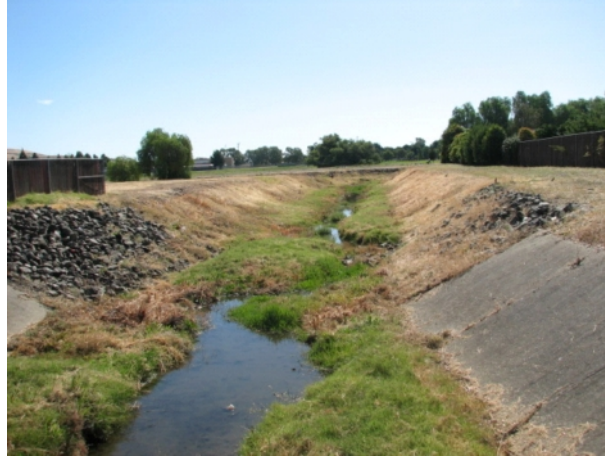
Levee Mile Report Line	36
Start Levee Mile	0.00
End Levee Mile	0.00
Location	
Category	Channels
Item	Vegetation & Obstructions
Downstream view from Gulf Dr. 38.28100 - 122.02057	
johngw_20090723_7.jpg
